ENGINEER'S SURVEY REPORT

2nd Hand House Survey

Property: 1 The Rise,
Apartment Block 1,
City Centre,
Dublin 1.

Inspected on: 1st July 2020

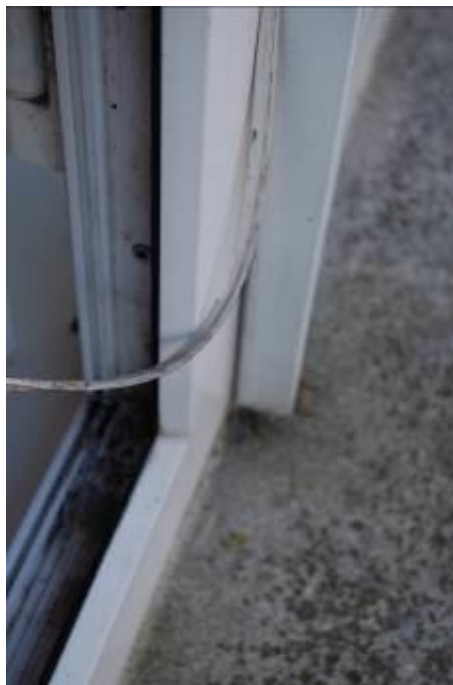
Internally all window frames are in good condition. Opening sashes are opening and closing correctly. Some of the window handles are worn and need replacement. A seal on the outside of the balcony door needs to be repaired.

Photo 2 Seal to Window Frame Needs repair

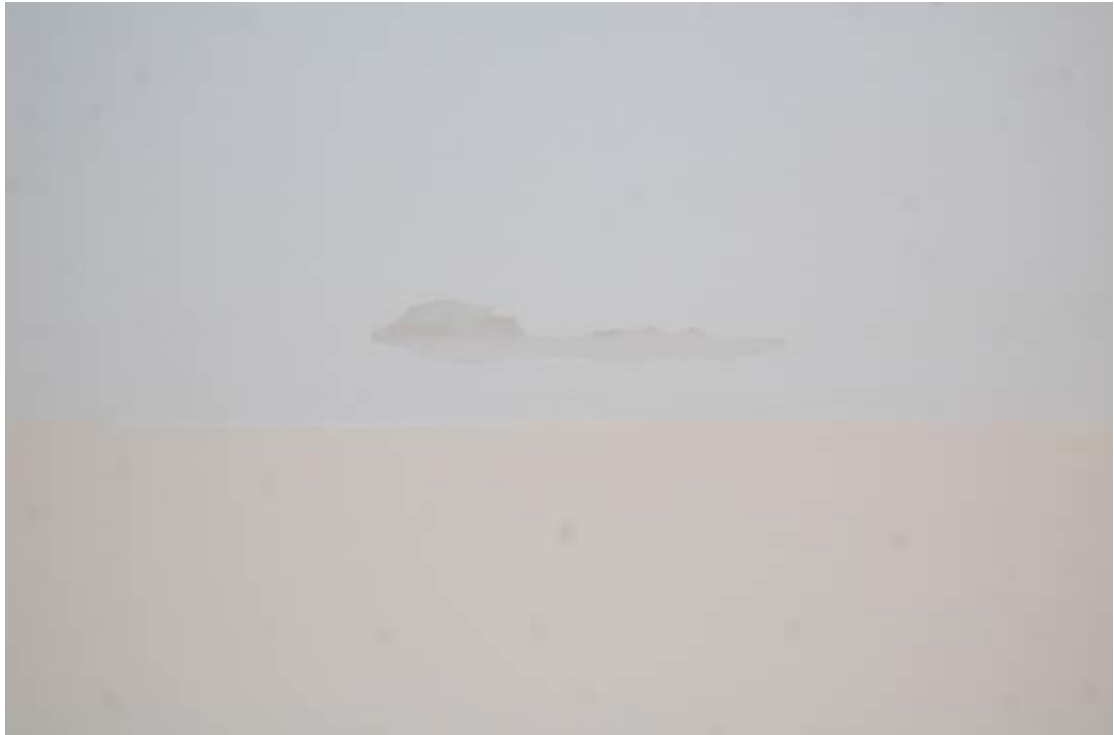
Ceilings are plaster board with a scim finish recently decorated and in good condition generally. Some marks are visible on the ceiling.

Photo 3 Marks on Ceiling Need to be Touched Up

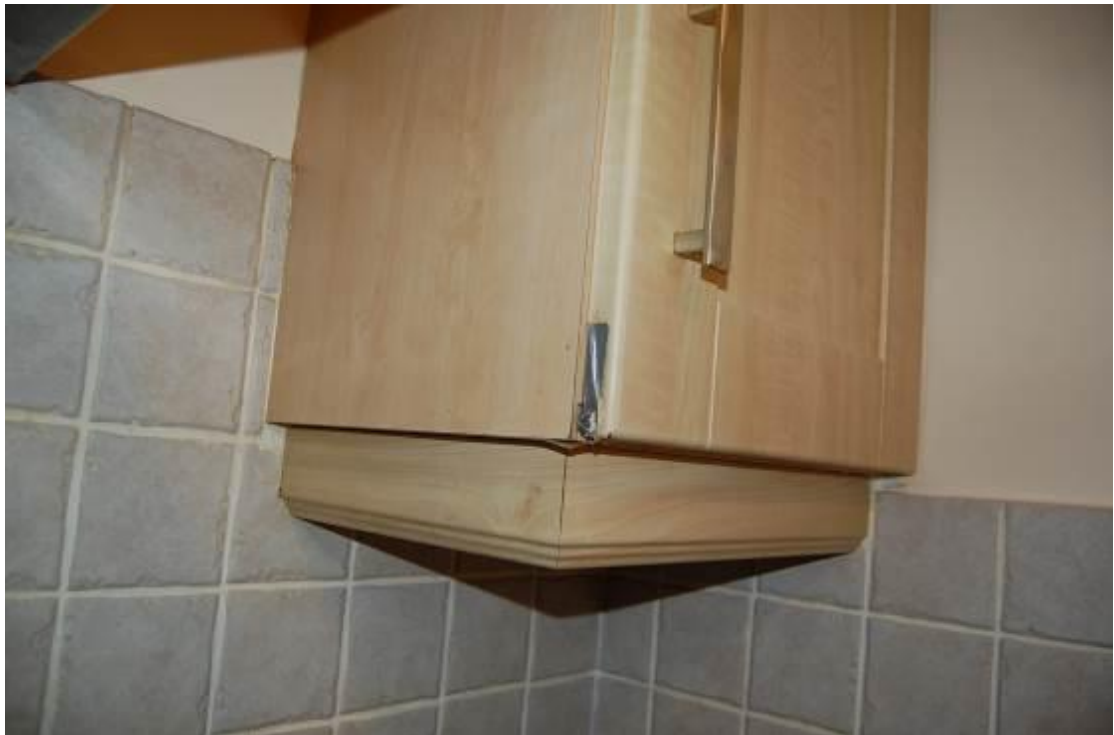
The kitchen area is small with a number of floor and wall presses. The units are functional but worn and there are little bits of damage to most of the doors. Replacement of the kitchen units will probably need to be considered in the short to medium term.

Photo 4 Damage to Corners of Doors (typical)

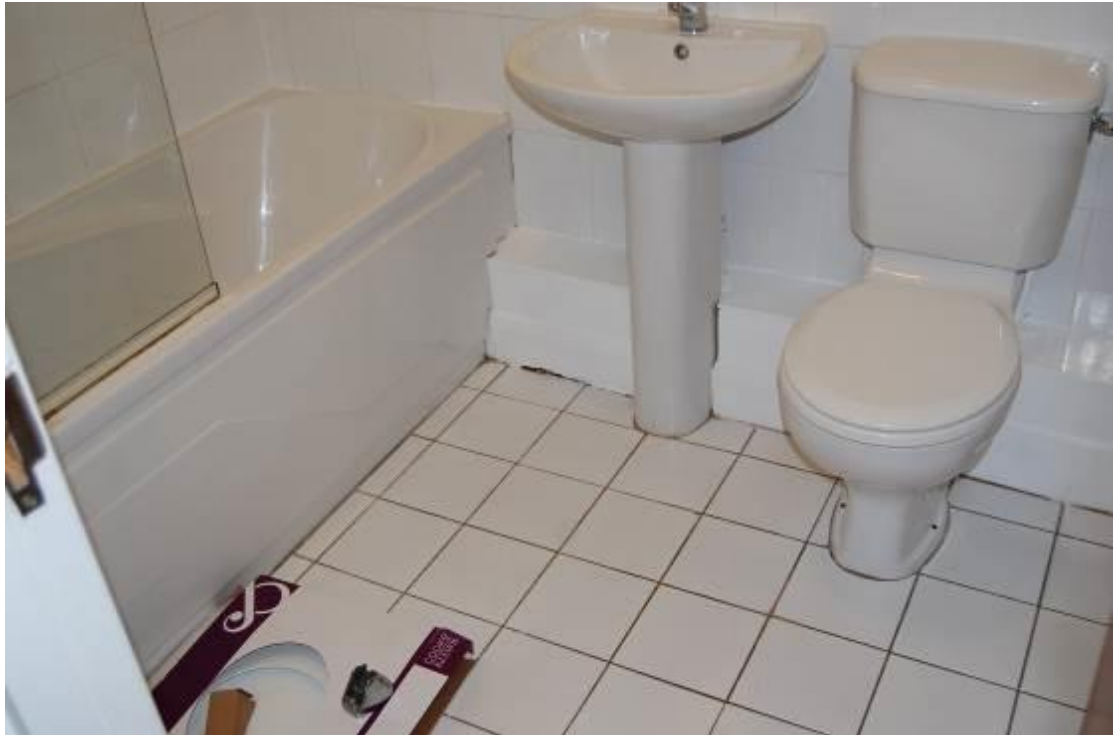
There is ceramic floor tiling in the bathroom and in the ensuite. The finish around the edges, in particular against the wall, is poor and some additional grouting is required.

In general the tiling needs either a good cleaning or updating.

The bathroom includes a bath, a WC and a whb. The ensuite has a shower, whb and WC. The sanitary ware is in reasonable condition, no cracks or leaks were noted but it all needs a good cleaning. Plugs are missing to whb's. All sanitary ware is operating correctly with no evidence of leaks or blockages in the drainpipes.

Photo 5 Tiles and Sanitary Ware need Cleaning/Upgrading

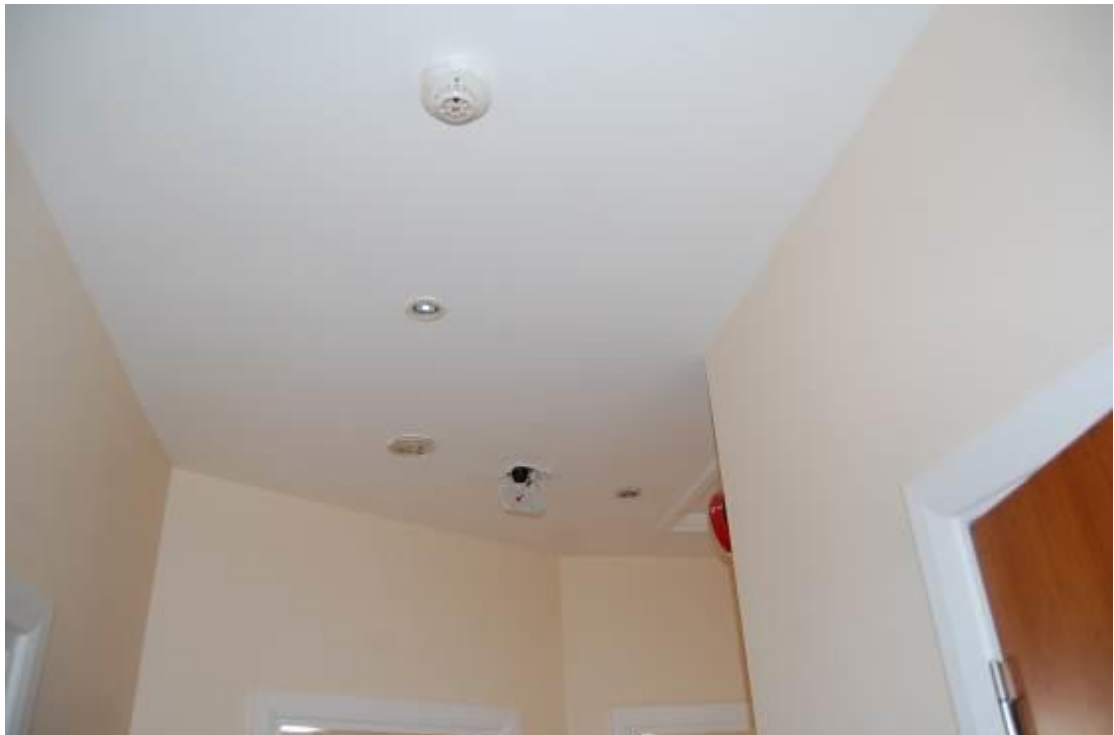
In addition to these there is a smoke alarm for the apartment itself which is not connected to the general fire alarm. This detector is the responsibility of the apartment owner. In this apartment the owners fire detector is unserviceable and needs maintenance.

Photo 6 Apartment Fire Alarm to be Maintained

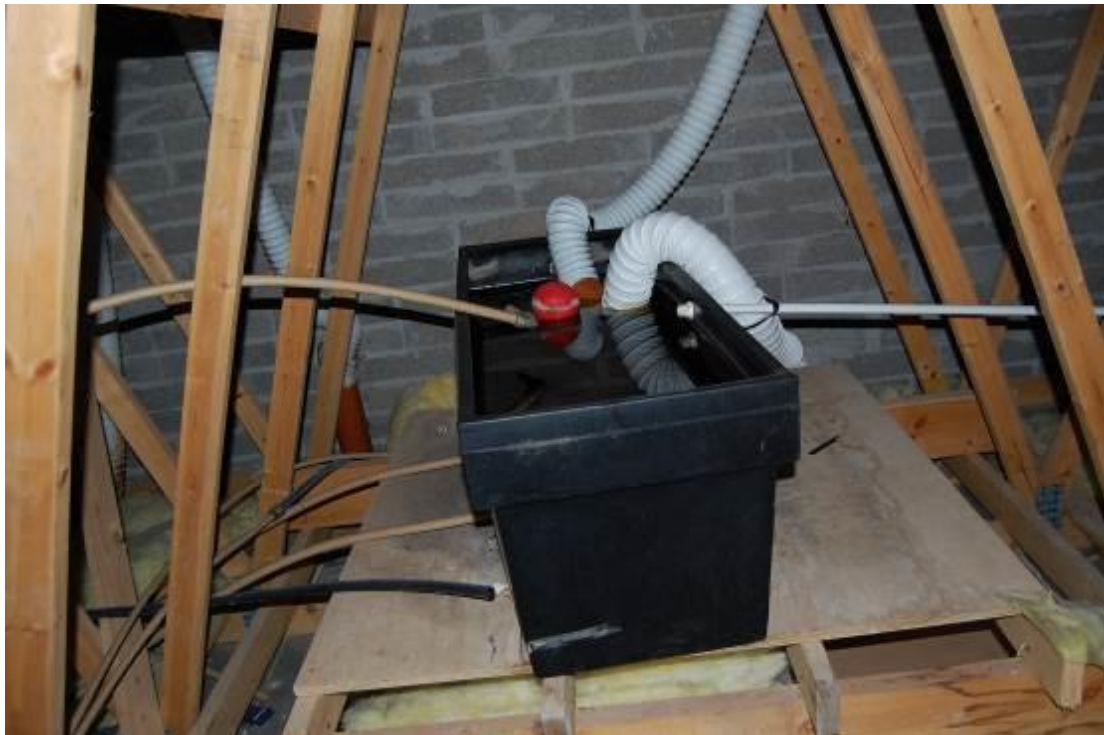
There is no cover on the tank. We recommend that a proper purpose made cover is fitted. We noted that one of the vent ducts has fallen into the tank and needs to be removed (see comments below and photograph in annex)

There are 5 vent pipes in the attic space. The bathroom and the ensuite each have a mechanical extract fan. There is an extract fan over the cooking hob. There is a soil vent pipe from this apartment and this is the duct that has fallen into the water tank.

The ducting to all of the vents is poorly installed. As noted earlier one of the ducts has fallen down and is partly submerged in the water tank. The ducting from the duct that serves the ground floor apartment has fallen apart and the duct is venting into the attic space. There is a mixture of types of flexible ducting used, some of which is very poor quality. We would recommend that all of the flexible ducting from the five pipes is replaced with better quality flexible ducting and securely fixed so that there are no dips in the pipe from the ceiling level to the roof outlet point.

Photo 7 Ducting that has Fallen into the Water Tank and tank not Insulated

There is no insulation to the tank and no insulation to any of the water pipes from the tank and all of these are sitting above the insulation. We strongly recommend that the tank and the pipes are insulated.

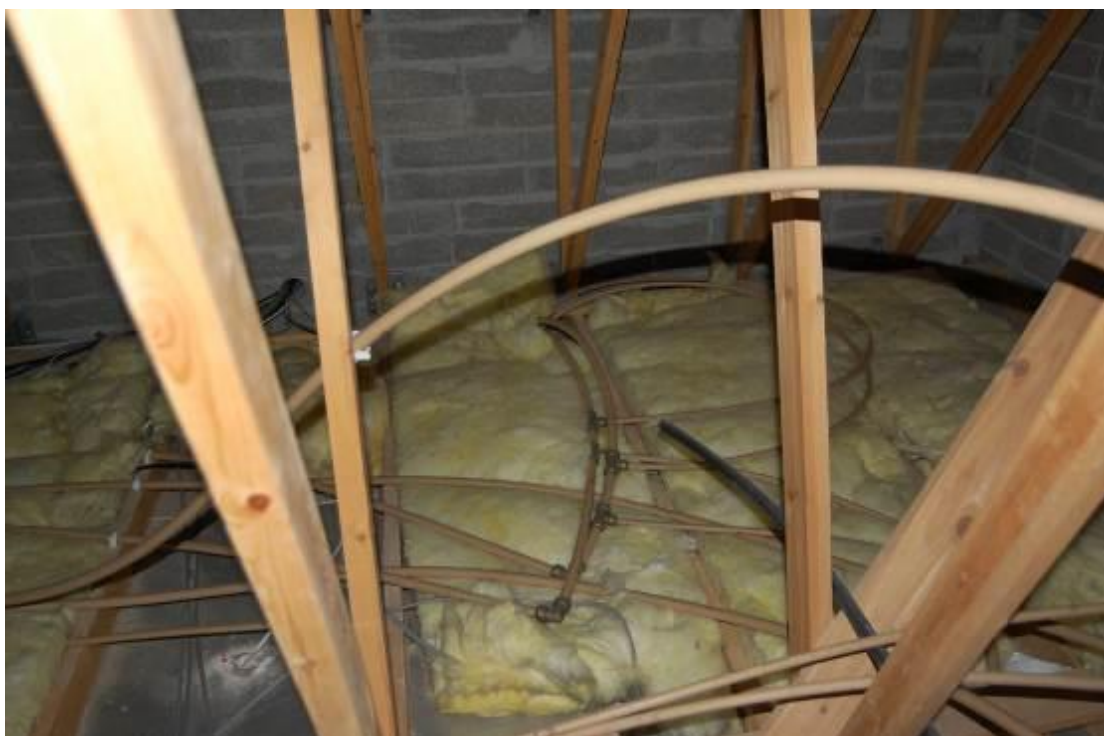
Photo 8 No Insulation to Water Pipes in Attic Space

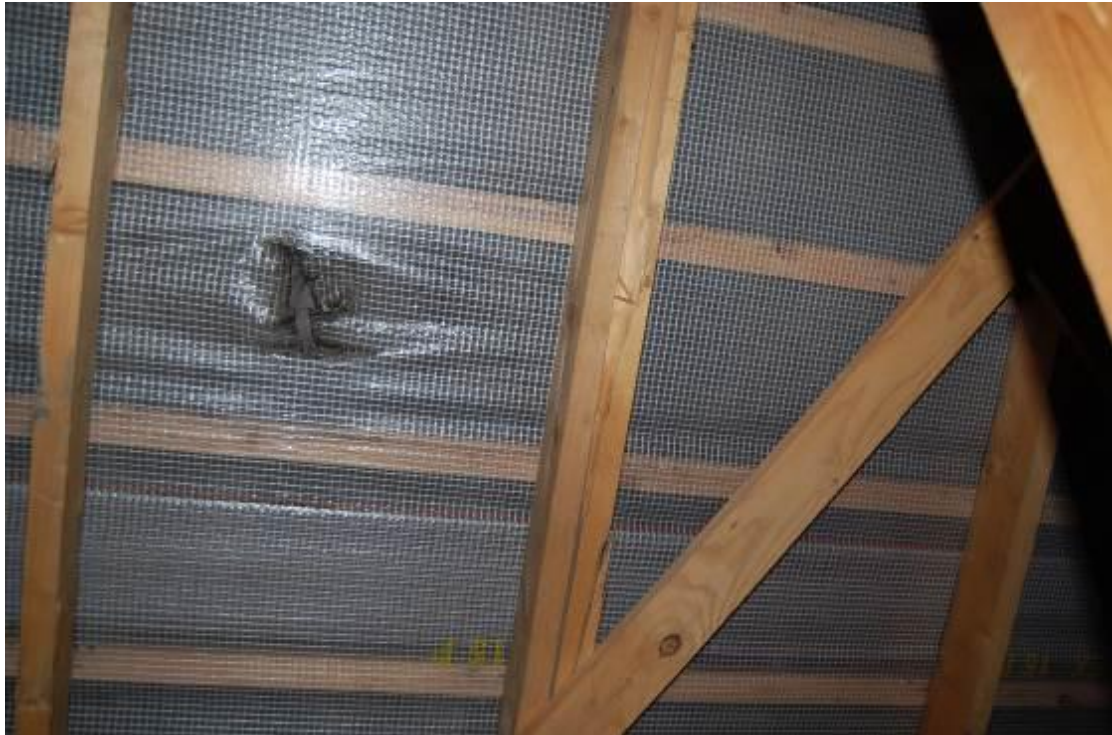
Underfelt is complete and generally in good condition. One tear was noted on the front roof slope near to the attic access hatch. This is not an immediate issue but if other works are being done in the attic space we recommend that the hole in the felt is repaired.

Photo 9 Tear in Felt to be Repaired

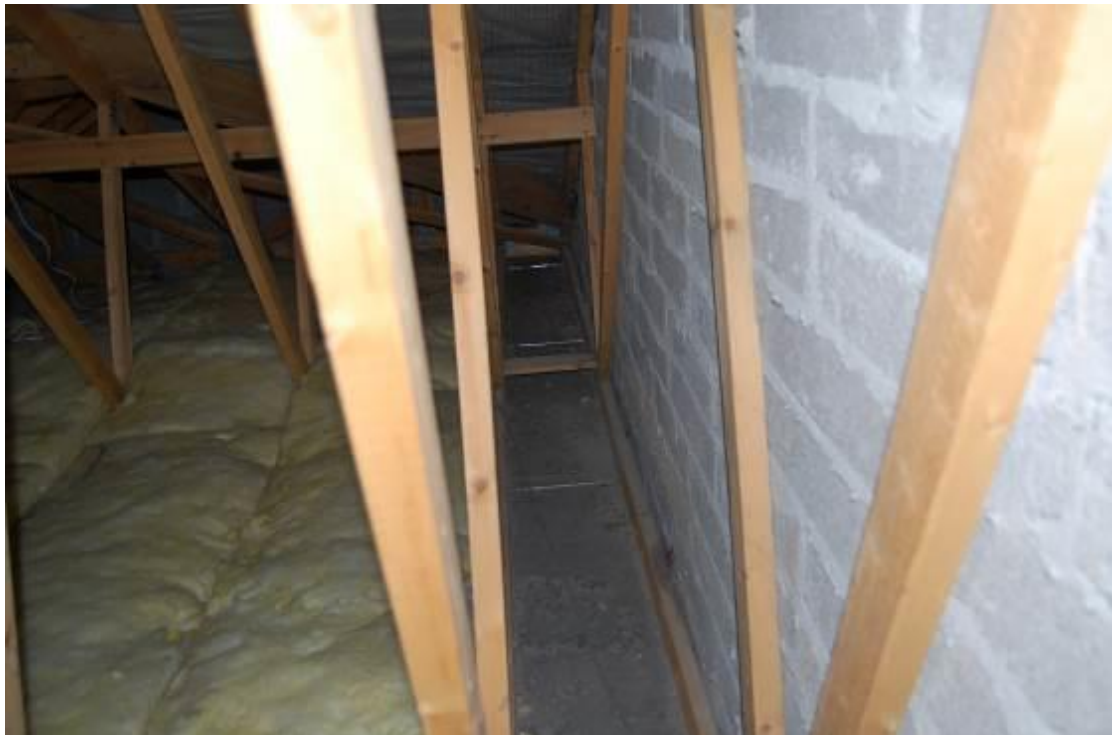
At both party walls there is a strip (approx 400mm wide) where no insulation was installed. We recommend that this area is insulated.

Photo 10 Strip near Party Wall with no Insulation (both sides)

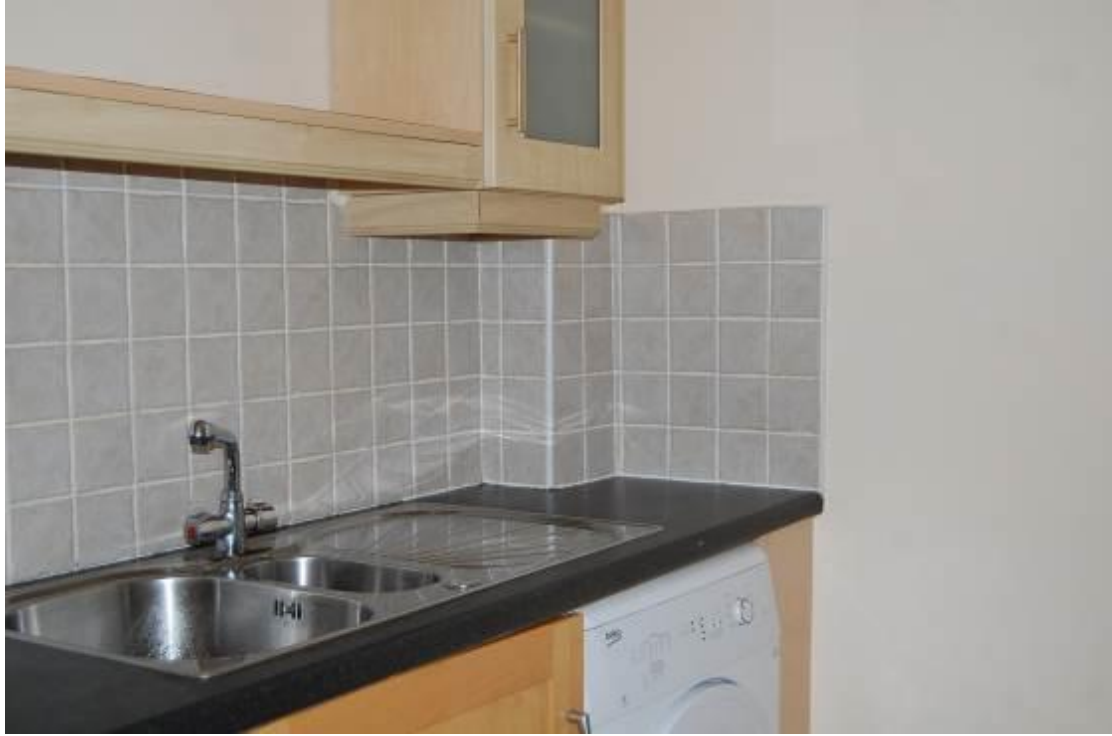
There is a fifth pipe within the attic space on the rear wall above the kitchen area. We noted that there is a boxed in duct in the corner of the kitchen and this is the duct that is above in the attic space. Our assessment is that this is a duct from the apartment below. If this pipe is coming from the apartment below then it should have a fire collar on the pipe at the floor level. This cannot be checked without major disruption. It is reasonable to assume that the fire collar is on the pipe and unless there is some other evidence we do not think it is necessary to check on this. However we recommend that the pipe in the attic space should have fire separation from the attic space of this apartment. This can be achieved by boxing in the pipe with fire proof materials. The pipe is tight against a block wall and hence this boxing in can be relatively easily achieved.

Photo 11 Boxed in Duct Pipe in Kitchen from Below
