ENGINEER'S SURVEY REPORT

2nd Hand House Survey

Property:	1 Dublin Road, Urban Town, Ireland.
Client:	Sean O'Brien
Inspected on:	1st July 2020
Inspected by:	P. Conran

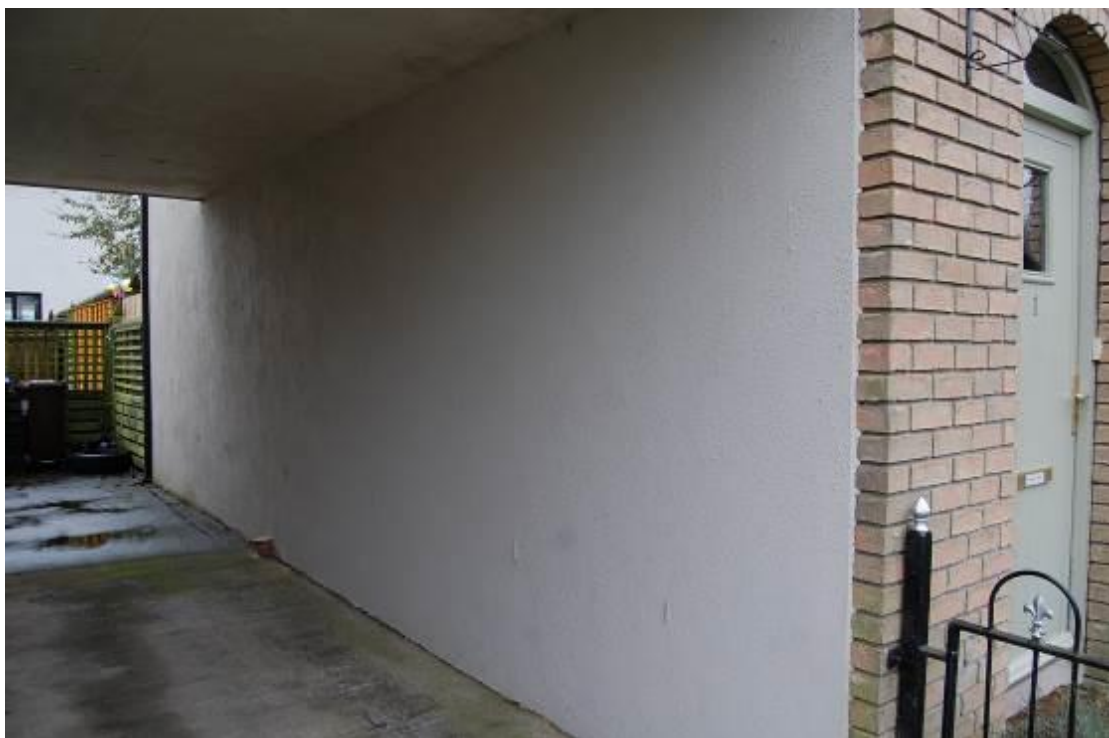
The property is North facing with the neighbouring semidetached property on the East side. The properties are linked at first floor level and not linked at ground floor level. At ground floor level there is an access passage to the rear garden of the neighbouring property. The passage is in the ownership of the

neighbouring property. This property has a gable wall at ground floor level that is covered over by the first floor overhead.

Photo 2 Side Elevation - Recommend that the ownership and rights to this area is clearly understood

It is our understanding that the owner of this property would have a right of access to the passage in order to maintain the gable wall or the underside of the first floor overhead. We recommend that the legal status of the passage way and any rights the neighbour would have to enclose the space, for example by erecting a garage door to the front, at a future date, are understood before the purchase is completed.

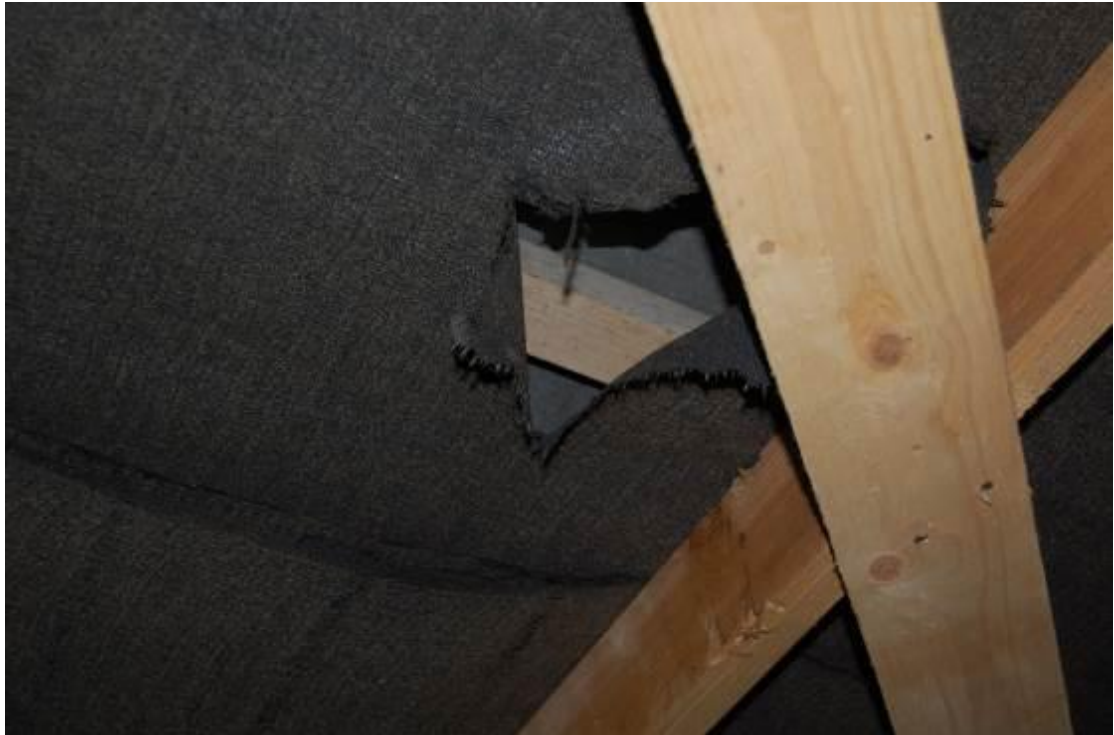
Underfelt is complete and generally in good condition. We noted one small hole in the felt near the party wall on the rear elevation. This is minor but we recommend that the hole is patched.

Photo 3 Small Hole in Sarking Felt to be Repaired

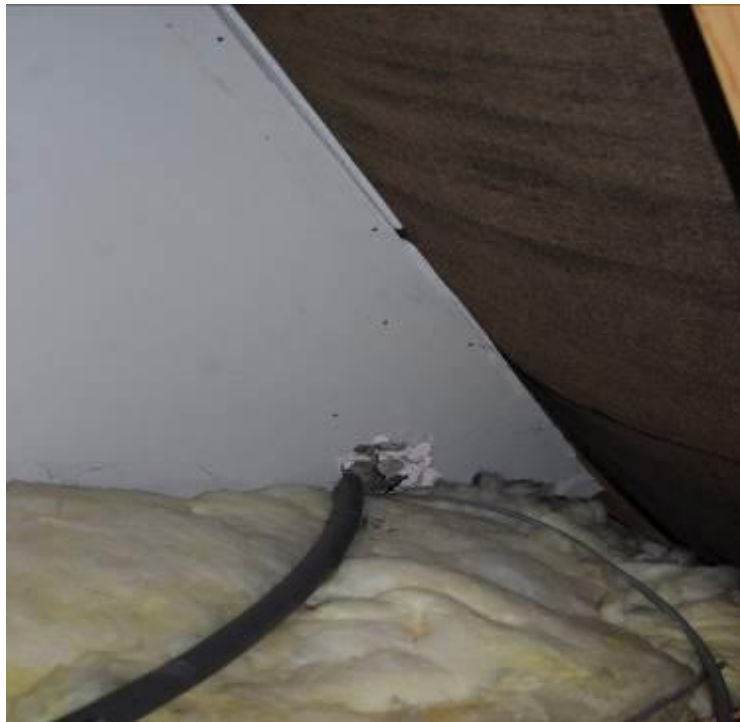
Double plaster board tightly fitted to the underside of the roofing felt. We noted that there is a hole in the plasterboard at ceiling level towards the rear where a water pipe feeds through to the attic tank. Our view was a bit restricted but there appears to be fire stop material around the pipe. However, we recommend that some additional fire stopping is done around the pipe to ensure that there are no gaps.

Photo 4 Hole around Water Pipe in Party Wall to be Fully Fire Stopped

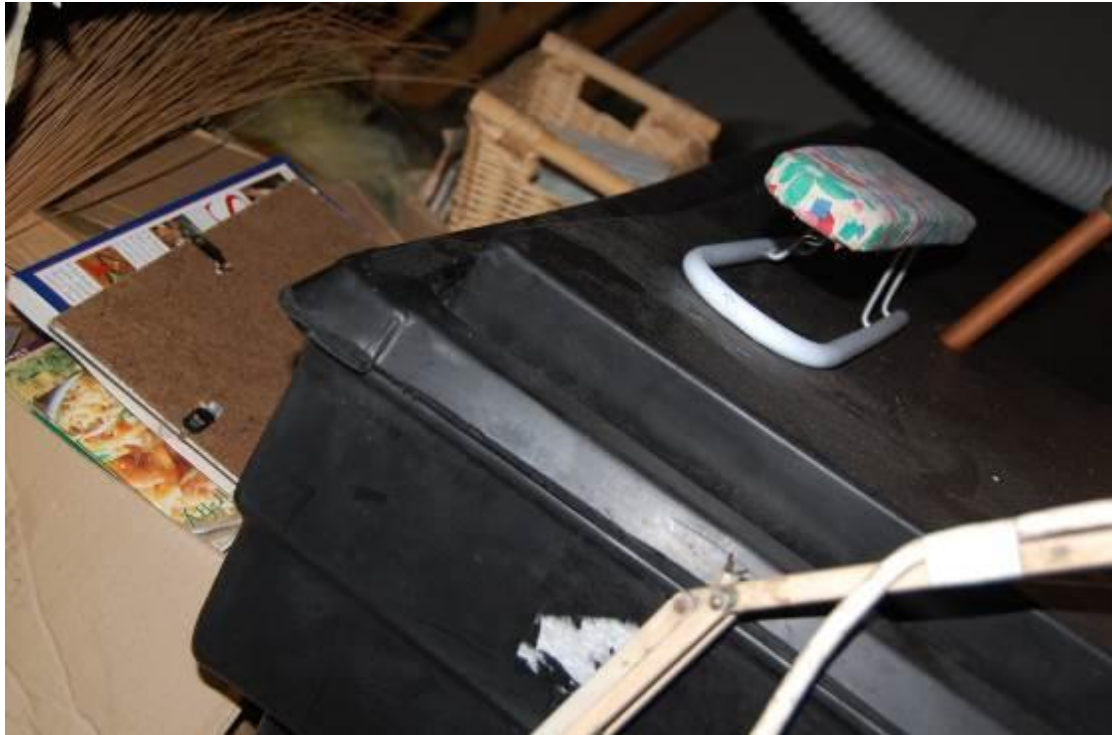
The tank has a lid but this is not insulated. We recommend that the tank is insulated.

There is no insulation below tank as recommended.

Photo 5 Water Tank in Attic Space to be Insulated

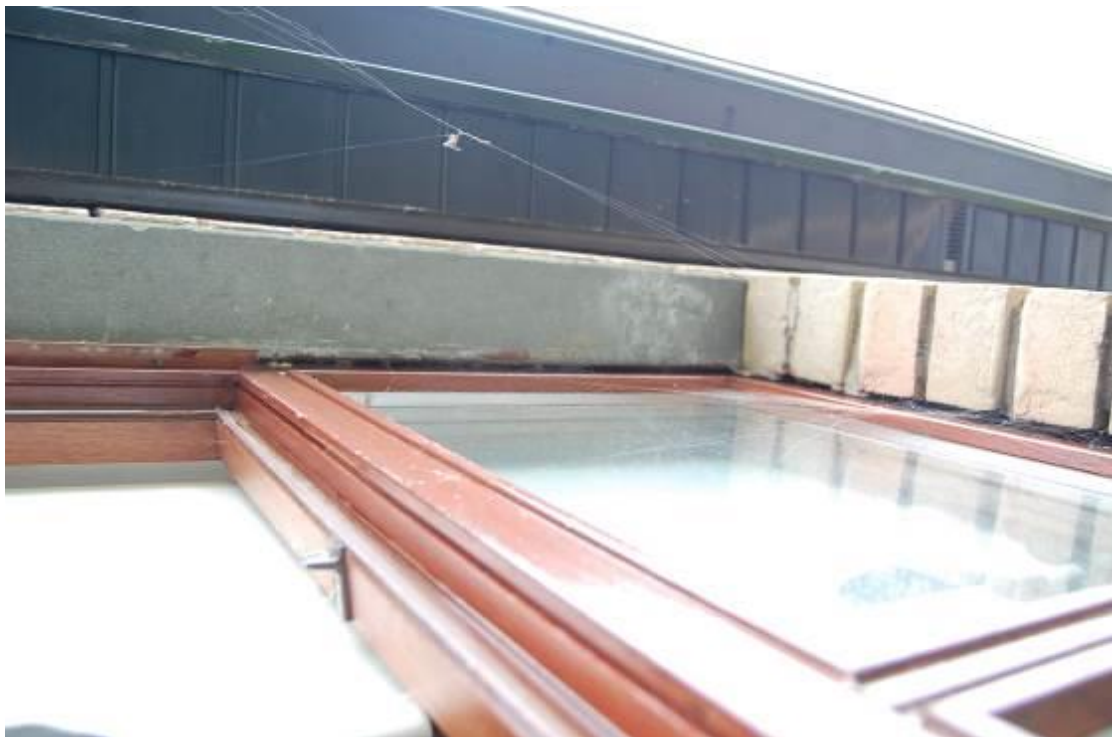
The window frame/brick reveal joint at first floor level to the front elevation was never sealed. Also the head of the windows was not sealed against the lintel. There is no damage evident from the lack of the seal but there is likely to be some draughts around the window frame and there is potential for the ingress of water into the cavity. We recommend that a seal is applied around the frames of these two windows at first floor level to the front elevation.

Photo 6 Missing Seal to Head and Reveal of First Floor Windows Front Elevation

On the front elevation the window frames at first floor level are not sealed against the lintel or brick reveals. No adverse effects are evident from this however; we recommend that a seal is applied.

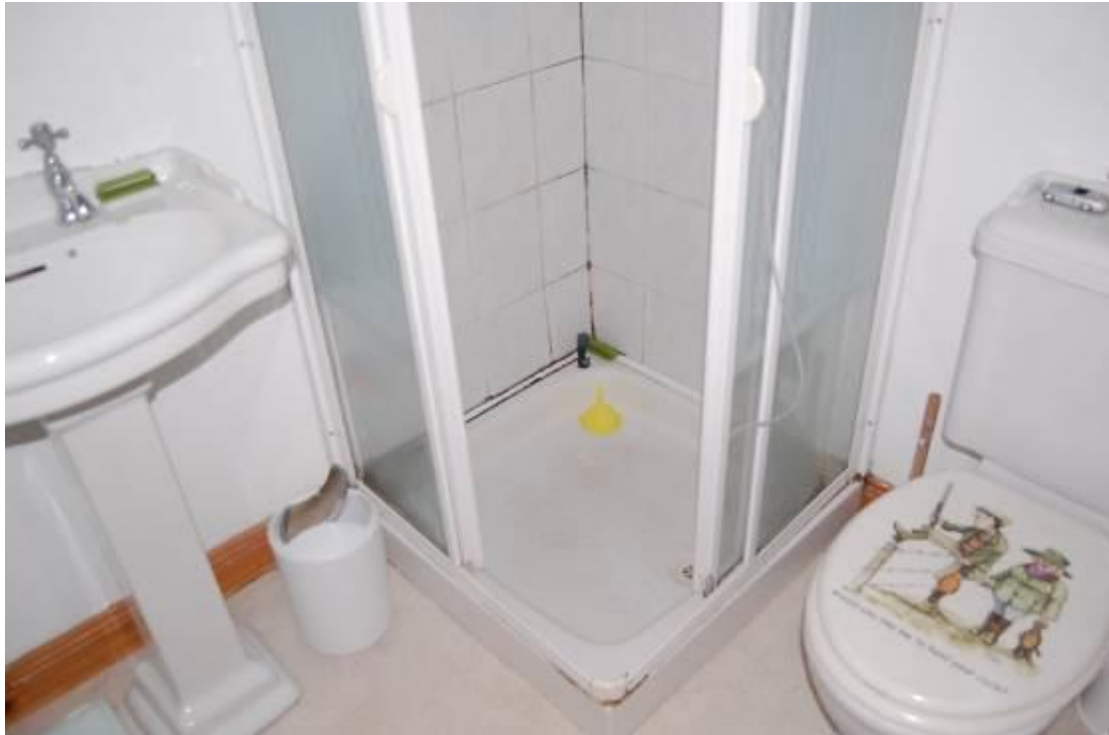
The tiling to the shower in the ensuite is in poor condition and retiling will probably be required. Ground floor WC with whb under the stairs in good working order.

Photo 7 Tiling to Shower to be Cleaned/Replaced

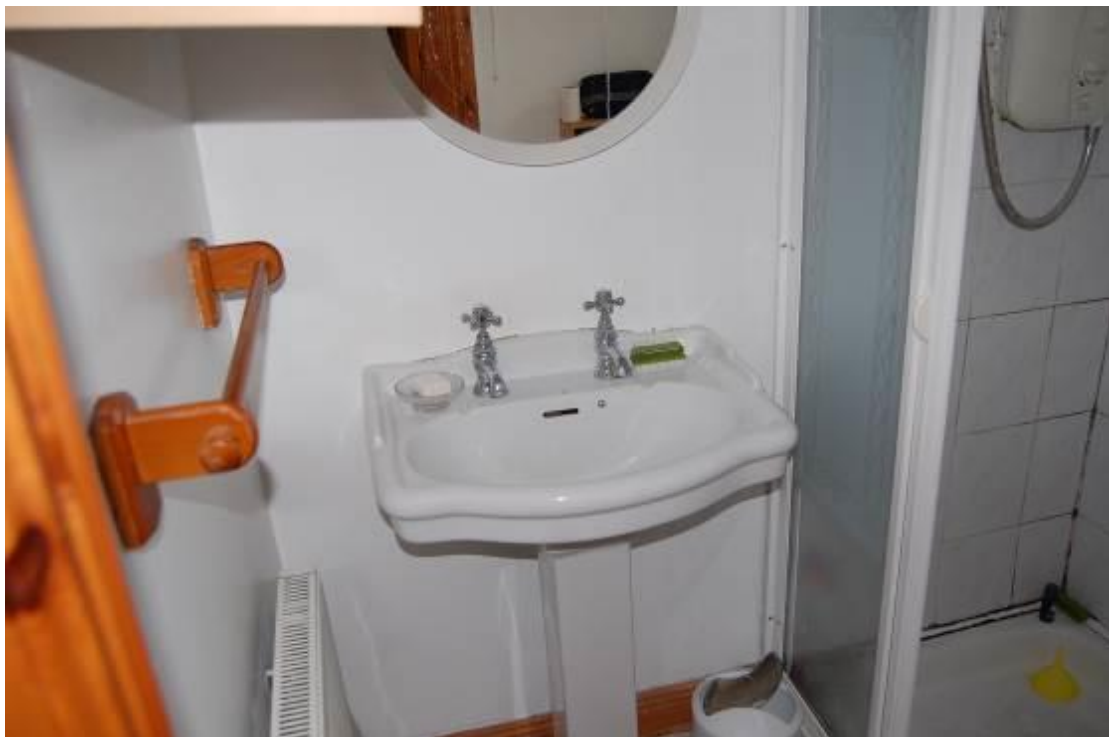
There is a family bathroom upstairs in the house. The bathroom includes a bath, WC, and WHB. All are in working order and no leaks were noted. One of the taps to the whb in the ensuite is not working. There is no water flowing through the tap and repairs or replacement of the tap are necessary.

Photo 8 Tap to WHB to be Repaired

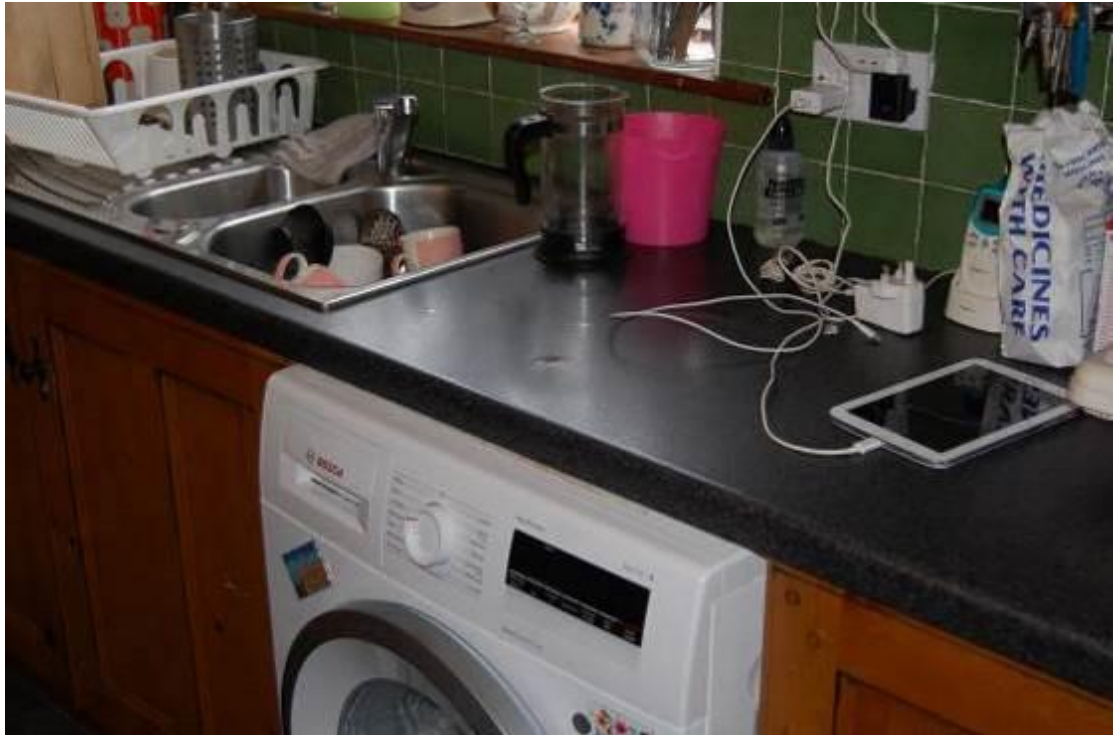
Kitchen units in good condition. The kitchen worktop has some damage with a break in the worktop surface near the kitchen sink.

Photo 9 Some damage to Kitchen Worktop
